B-1 bomber stabilizers to get stronger substructures

by *Darren D. Heusel*
Oklahoma City Air Logistics Center Public Affairs

09/05/01 - **TINKER AIR FORCE BASE, Okla. (AFPN)** -- Maintainers here will be beefing up the horizontal stabilizers on the tail sections of the Air Force's 93 B-1B Lancers during the next six years. The procedure will make the stabilizers safer and sturdier.

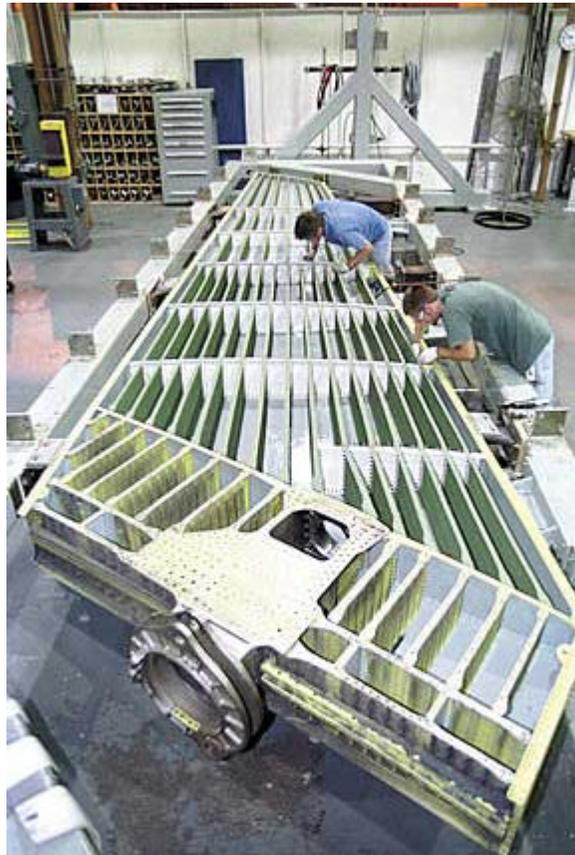
Larry Elliott, (rear), and Donald Ticer, sheet metal mechanics in the B-1B Lancer Horizontal Shop at Tinker Air Force Base, Okla., attach rib lines to spars in a B-1B horizontal stabilizer. (Photo by Margo Wright) | [High-Res Version of this photo](#)

Horizontal stabilizers, which measure 25 feet long, 8 feet wide and 1 foot deep, provide the bomber's pitch and roll. They are made of aluminum skins with 25 titanium spars running lengthwise and a number of aluminum ribs crisscross the spars.

During the repair, workers remove the upper aluminum skin, which has about 3,500 fasteners, take out the old spars and ribs and replace them with new, sturdier parts.
